# Boston's Open Space

1987  
PARK EVALUATION  
&  
SITE SUMMARIES

EVALUATION OF  
CITY OF BOSTON  
PARK AND RECREATION LAND

NEIGHBORHOOD OF ALLSTON/BRIGHTON

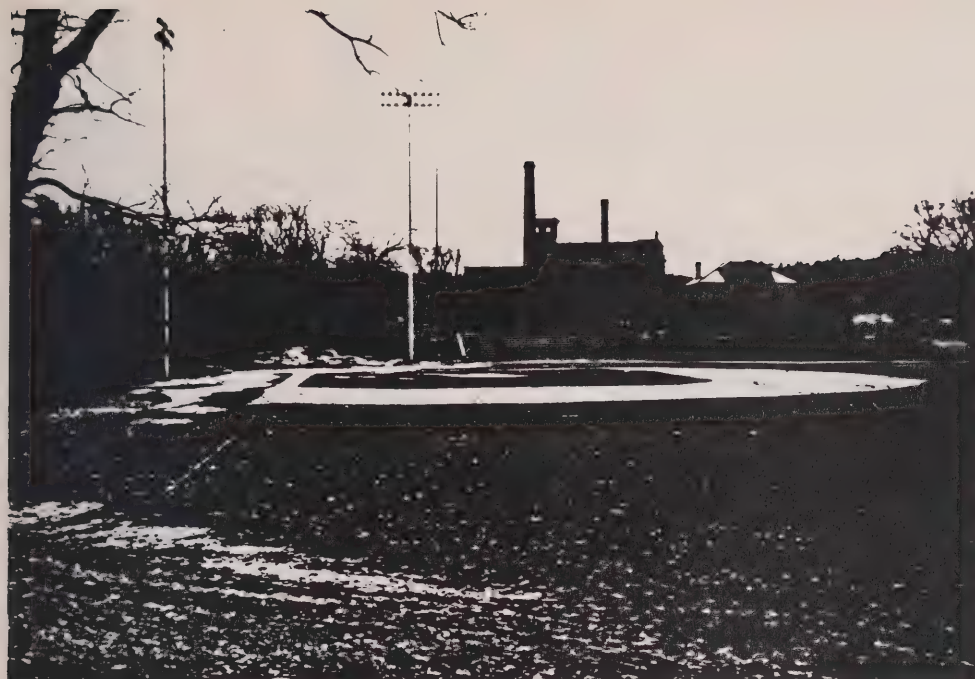
### **Site Photograph 1**

Baseball court and bleachers beyond. Due to uncontrolled vehicular access, cars drive across lawn and do much damage.

There is a need for auto control, both around parking areas and access roads, as damage to the fields has resulted from uncontrolled access of cars into the park.

Uncontrolled access of cars into the park has led to damage of the sports fields. The maintenance vehicle access road is an asset to the park, and well located at the edge, but it needs an access control structure.

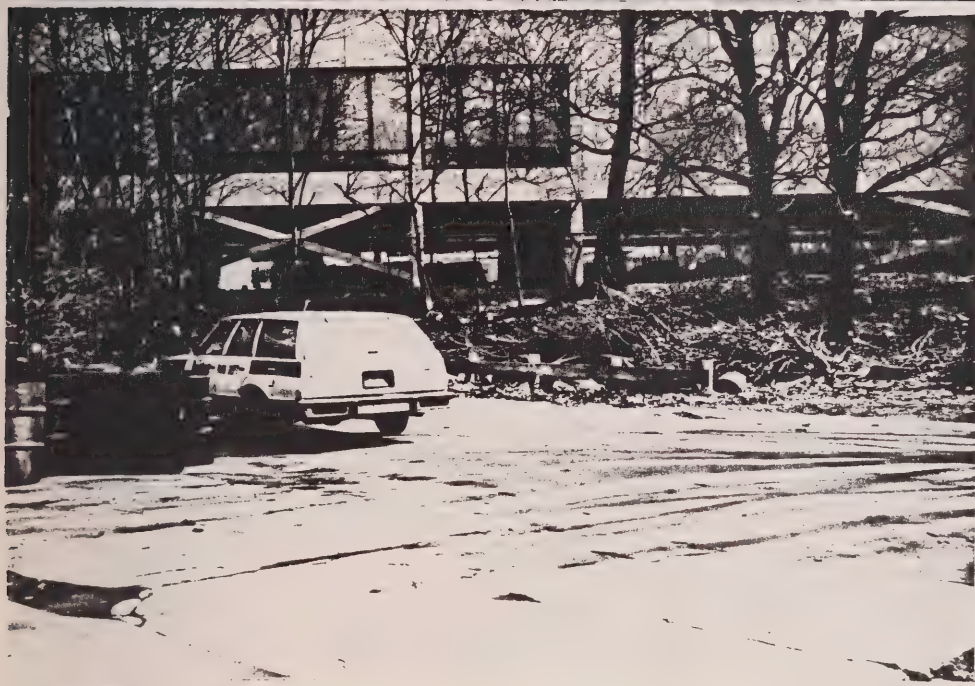
### **Site Photograph 2**

Back of maintenance building used inappropriately as a dumpsite. This area a "hidden corner".

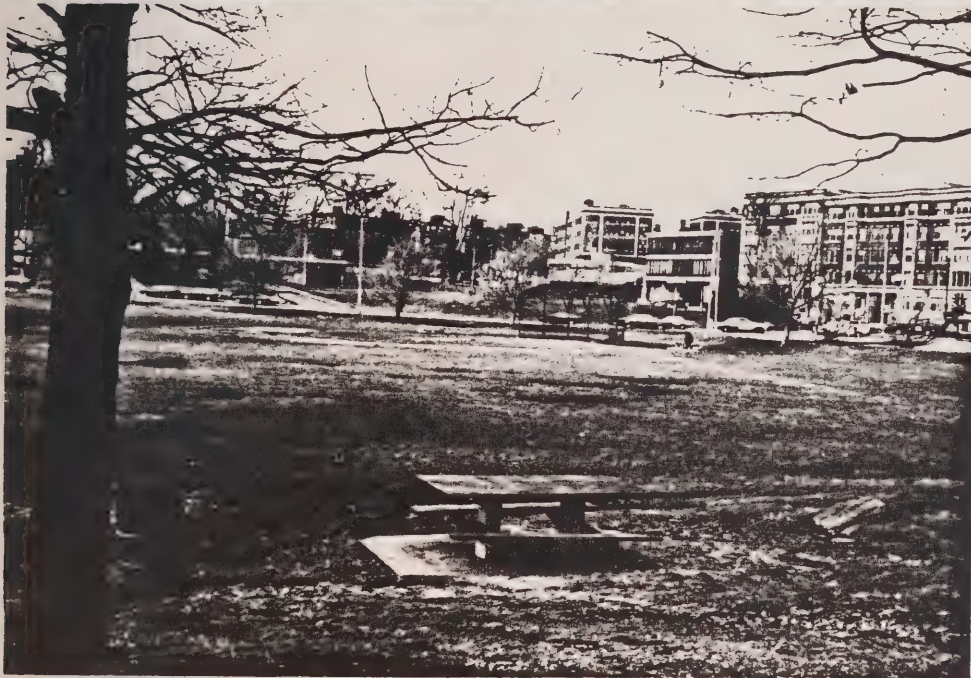
#### Site Photograph 5

Grass under trees in need of repair.

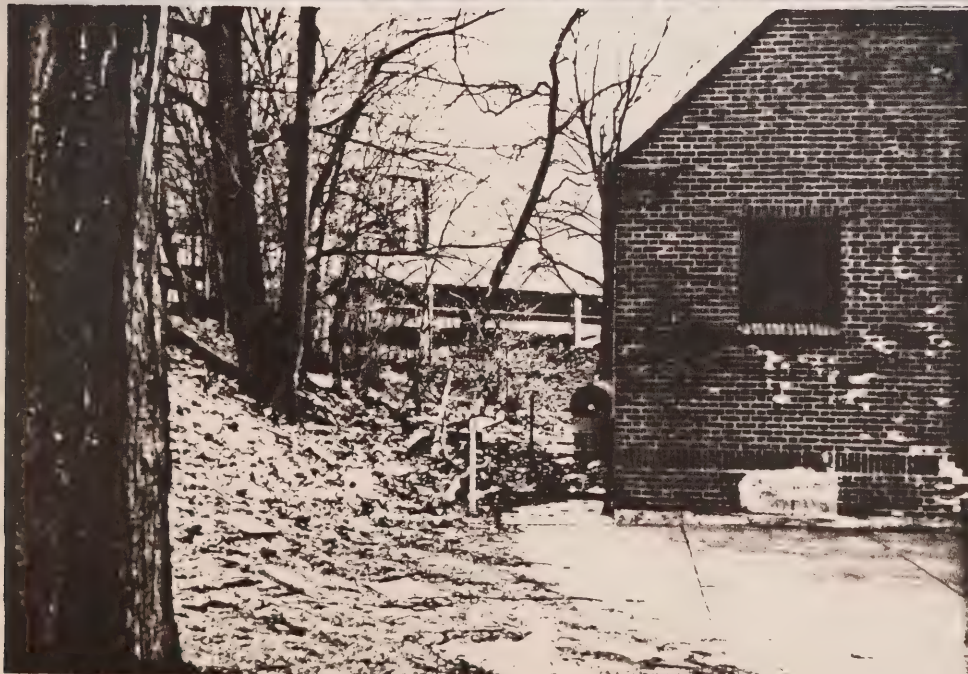
#### Site Photograph 6

Trash behind building. Building in great need of repair. Currently being used for maintenance.

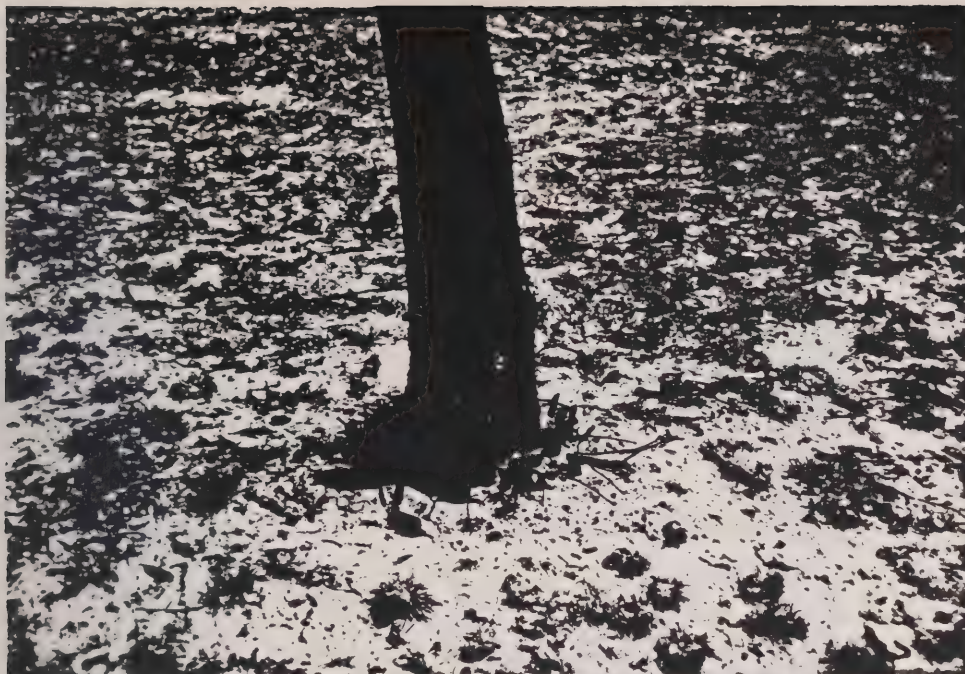
**Site Photograph 1**

Mechanical damage  
caused by mowing  
equipment.

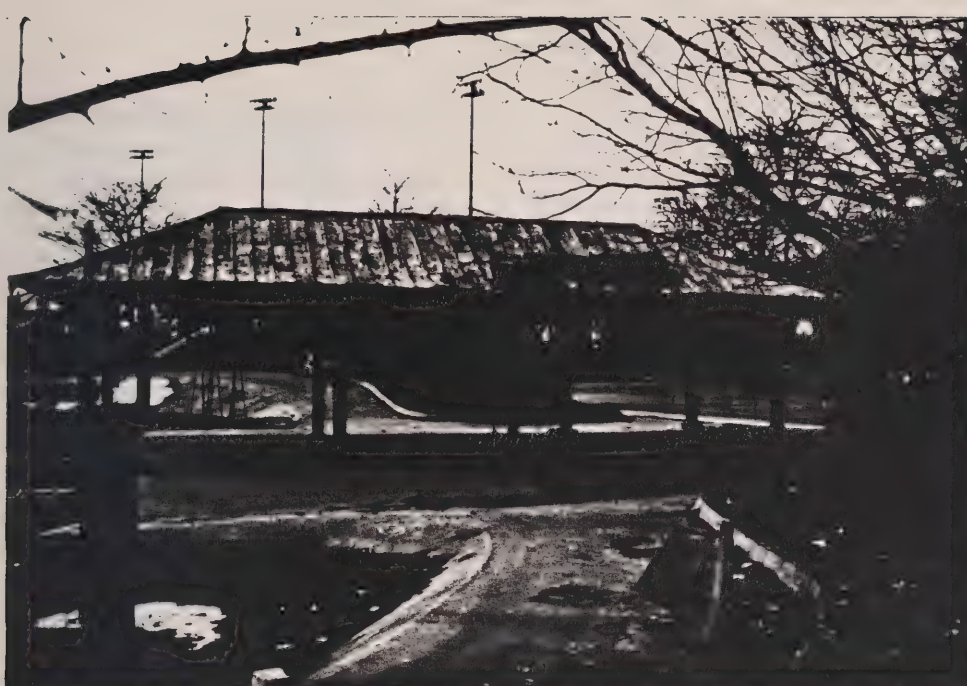
**Site Photograph 4**

Although roof is in poor condition, shelter structurally sound. Note grass growth in sand and pavement cracks. Bermed area behind overgrown.

Although the open-air shelter is structurally sound, the roof is in very poor condition.

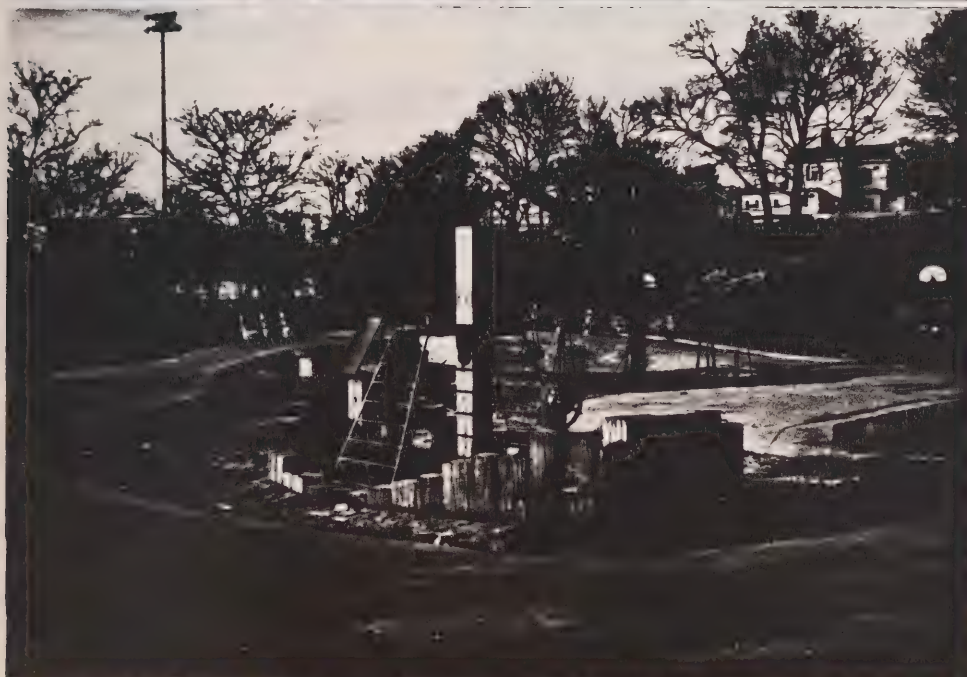
**Site Photograph 5**

Playground. Tire swing behind has been scorched. Example of safety problem - sharp points on ship's wheel. Rotten wood.

The playground structures have deteriorated and are badly vandalized. Broken glass and debris cover the sand surface, and equipment has protruding hardware, rotten wood and broken parts.

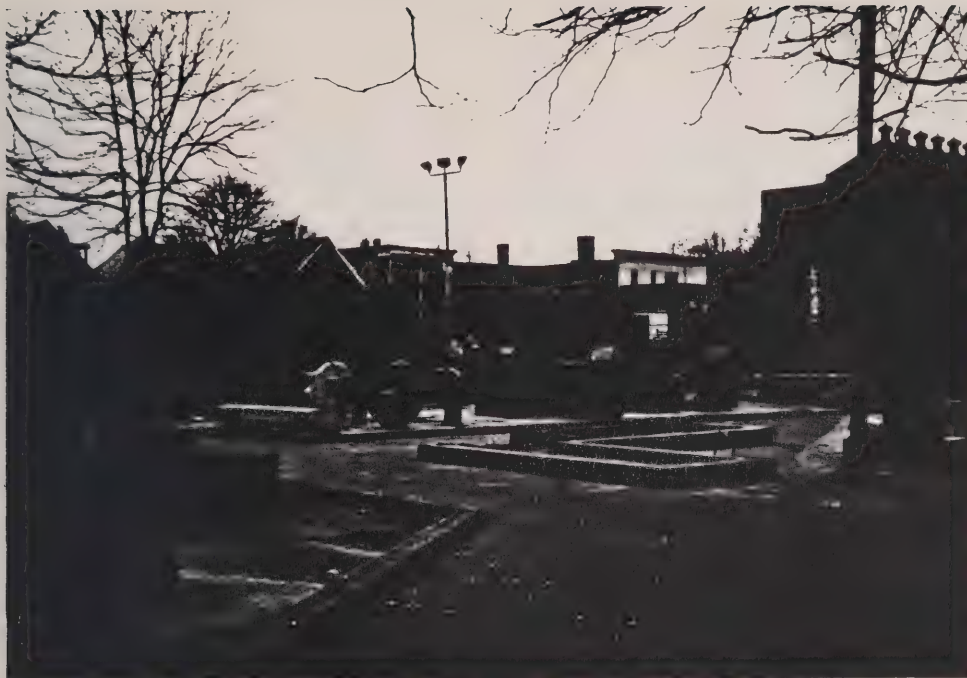
**Site Photograph 1**

Playground. Concrete equipment in good condition. Wood edging and play equipment either broken or of low play value.

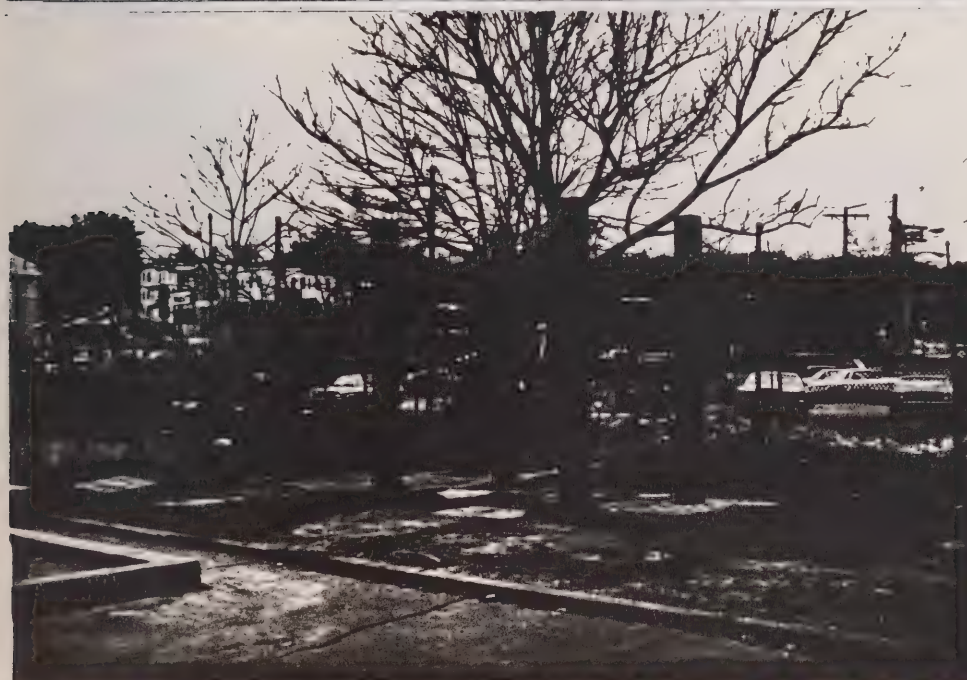
**Site Photograph 2**

Timber play structure and concrete frogs (broken). Play surface in poor condition and unsafe.

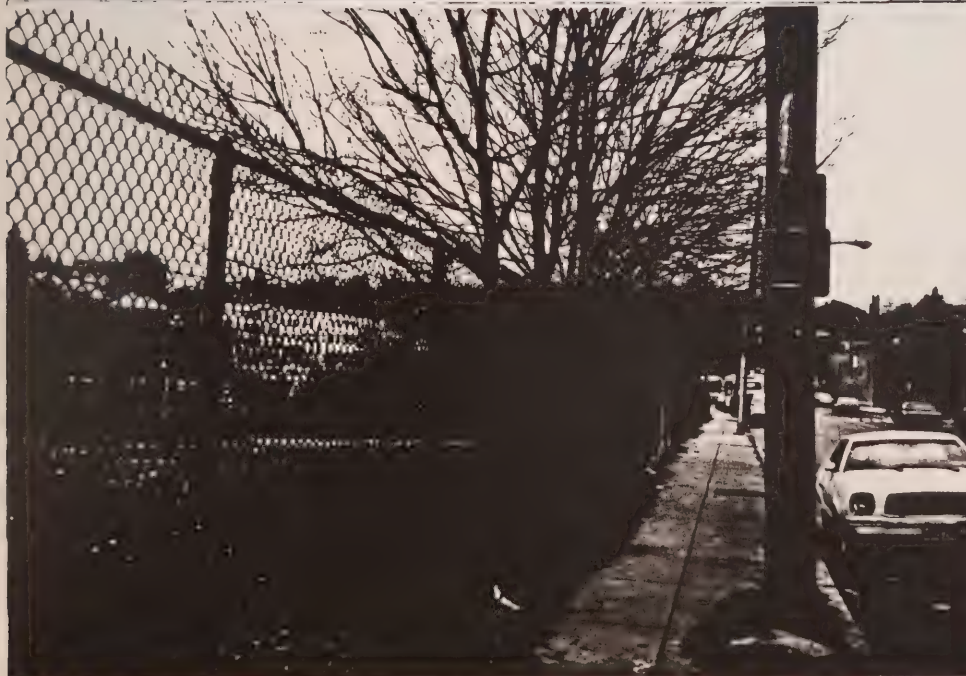
**Site Photograph 6**

Uninviting view of  
park from street. Does  
fence need to be so  
high?  
Trees in vigorous  
condition.

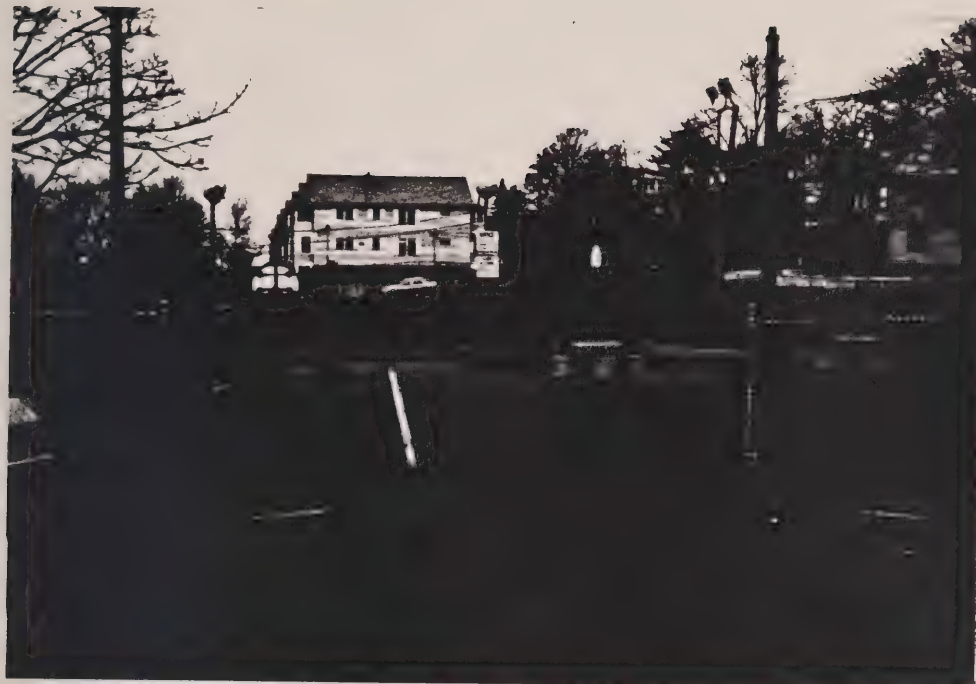
### **Site Photograph 4**

Maintenance access point.  
Other vehicles can  
enter also.  
This photo shows all  
the main park features.

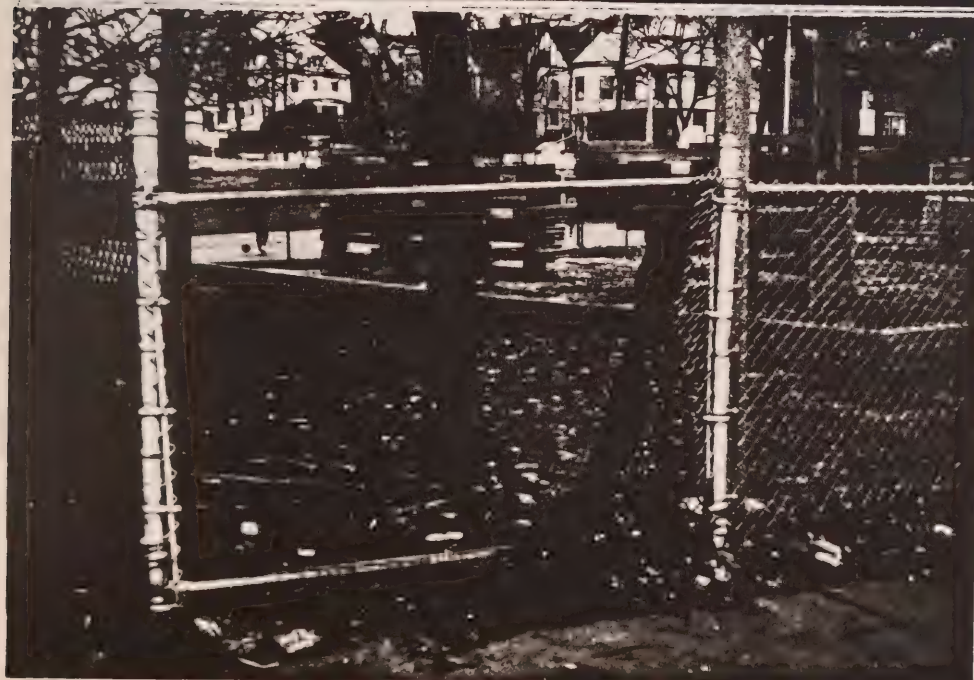
### **Site Photograph 6**

Short cut through  
fence. Despite  
compaction, the trees  
are doing well.

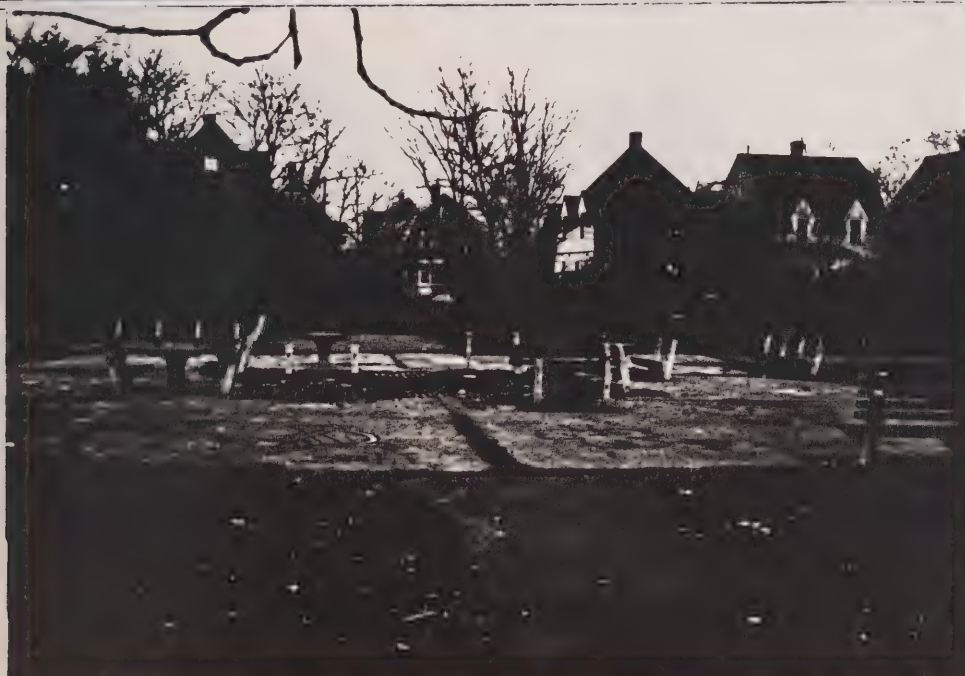
### **Site Photograph 2**

View into center of park. Shows graffiti, broken benches, glass.

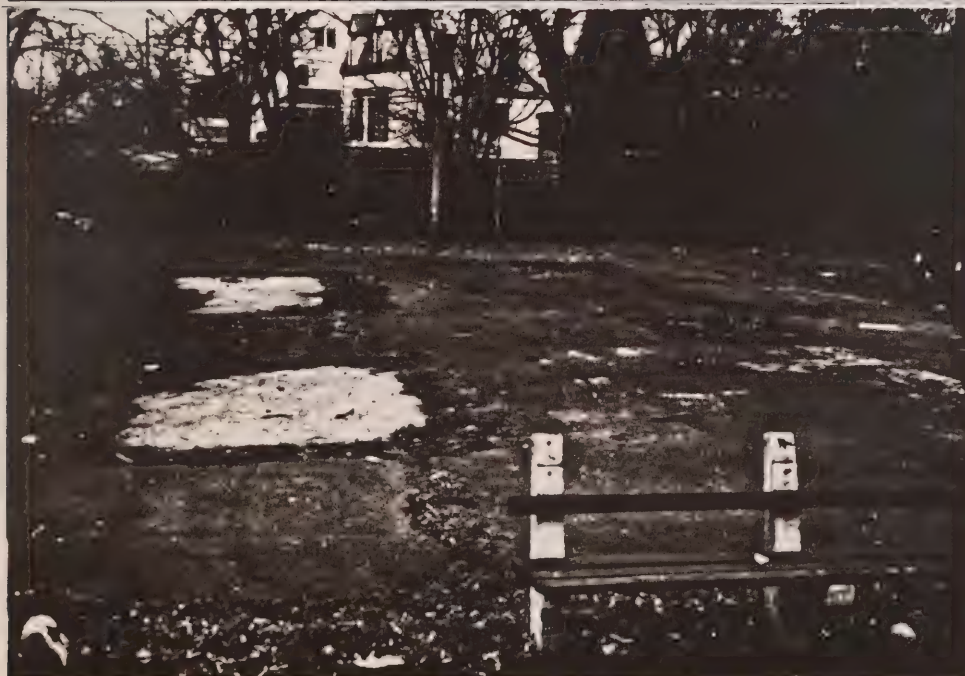
### **Site Photograph 3**

Concrete foundations for picnic tables and empty tree pits. Light with missing globe. R.O.W. access through fence.

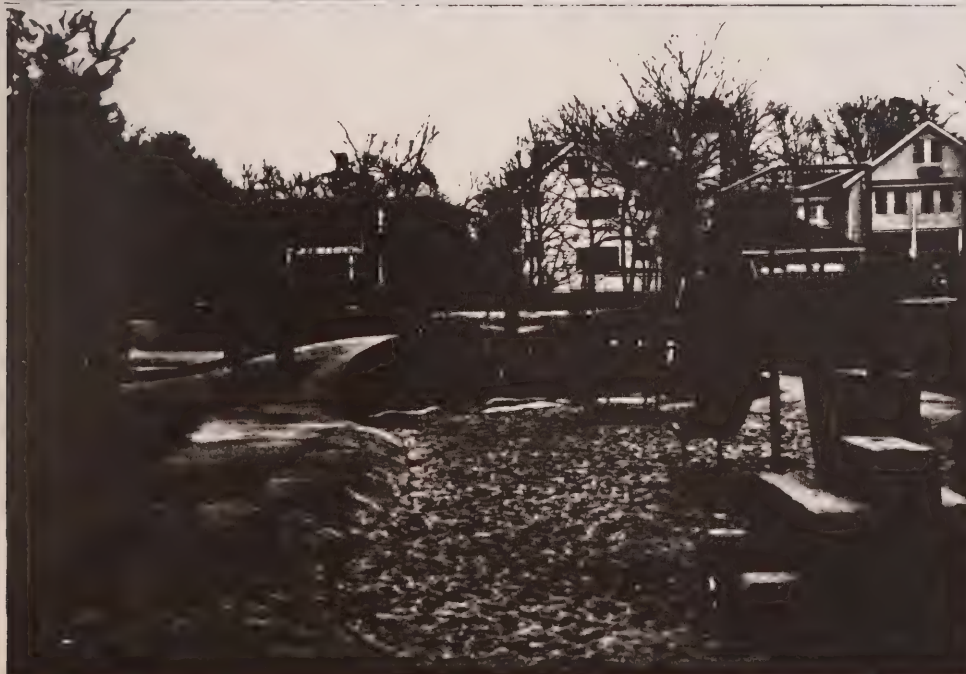
**Site Photograph 3**

Graffiti on wall.  
Playground equipment  
in good condition.

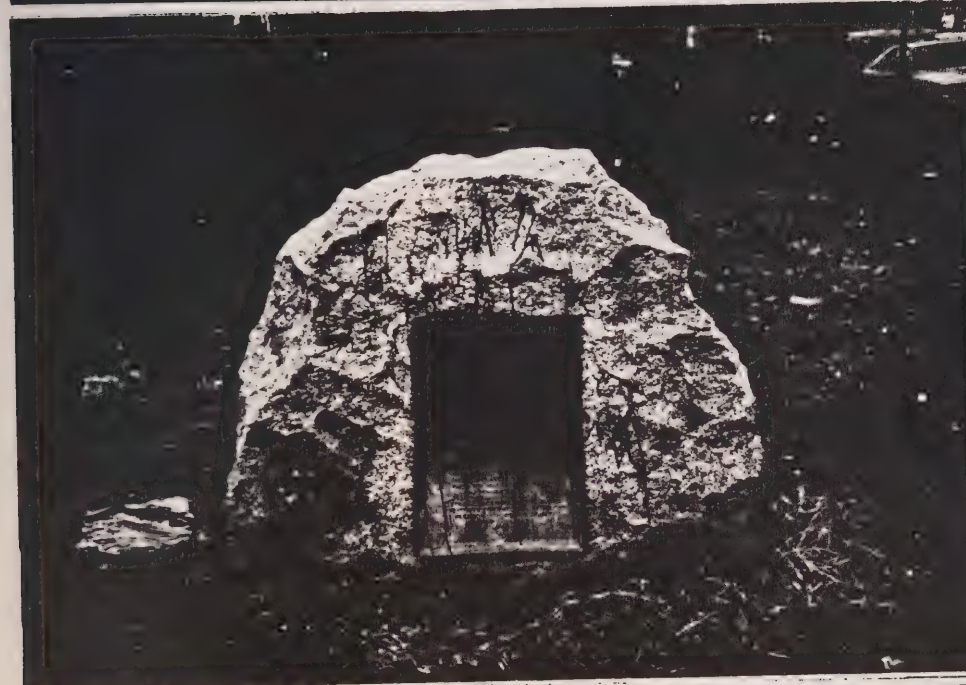
**Site Photograph 8**

Memorial with graffiti.

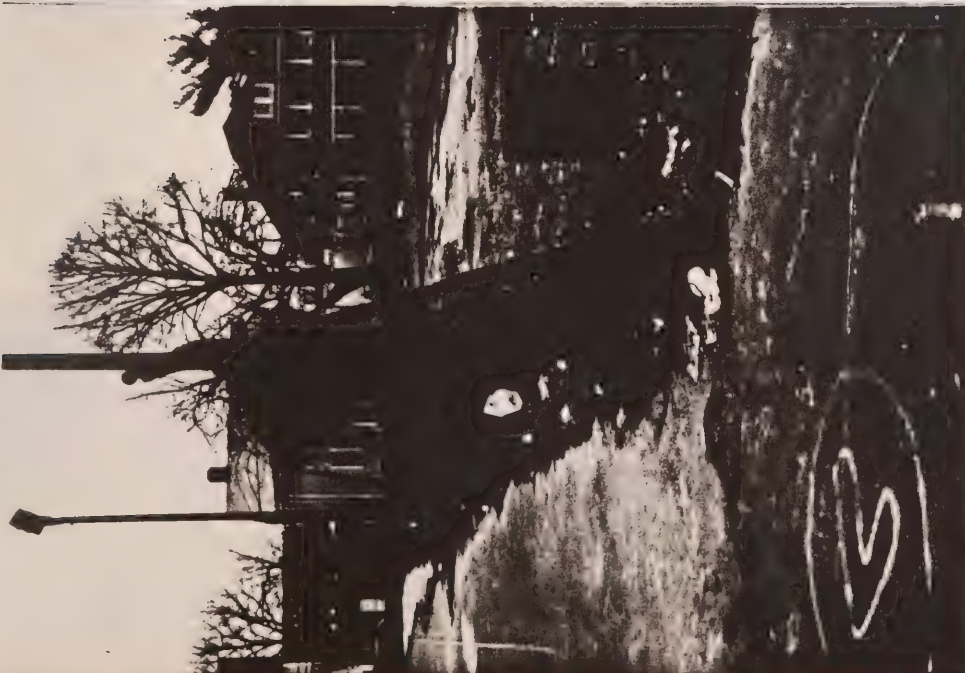
**Site Photograph 3**

The only trash  
receptacle on site.  
Fence in very poor  
condition.

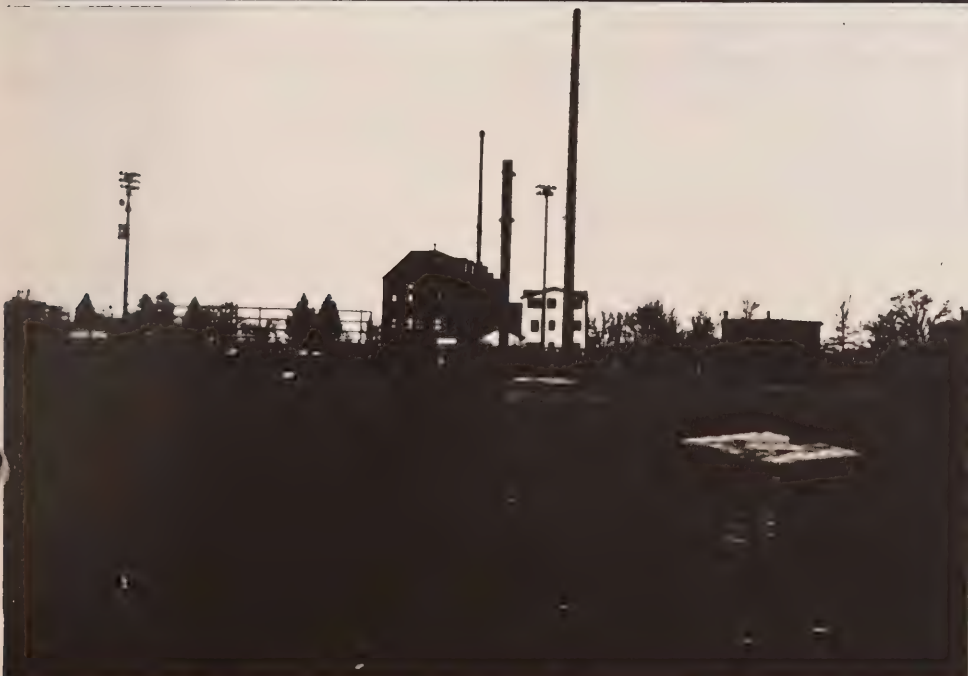
**Site Photograph 6**

Entrance to park from  
Portsmouth Street.  
Concrete block as  
access control.  
Wall adds character to  
site. Some visibility  
problems with wall,  
however.

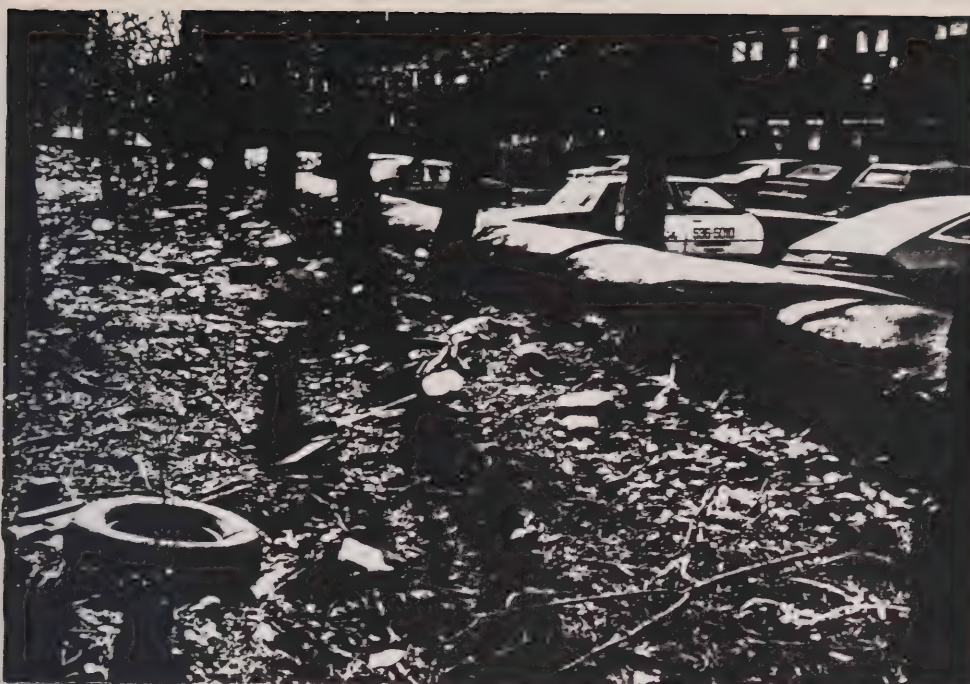
#### Site Photograph 4

Natural area near parking lot, place where there is no fence. Dumping a problem here.

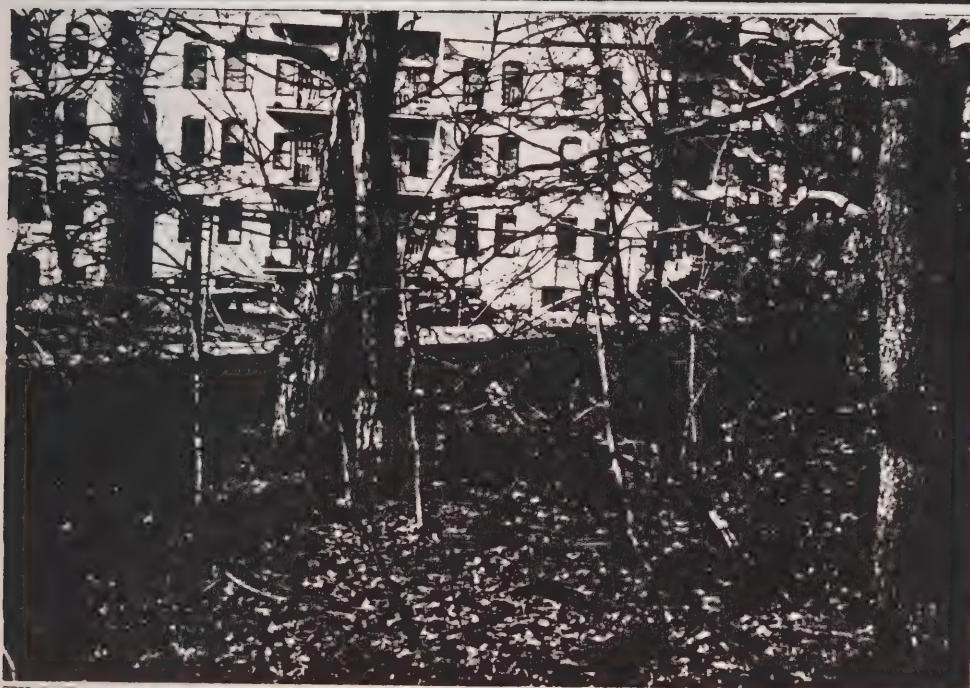
**Site Photograph 2**

Typical view out from park towards apartment buildings and parking to southwest. Poor interface, with no access points.

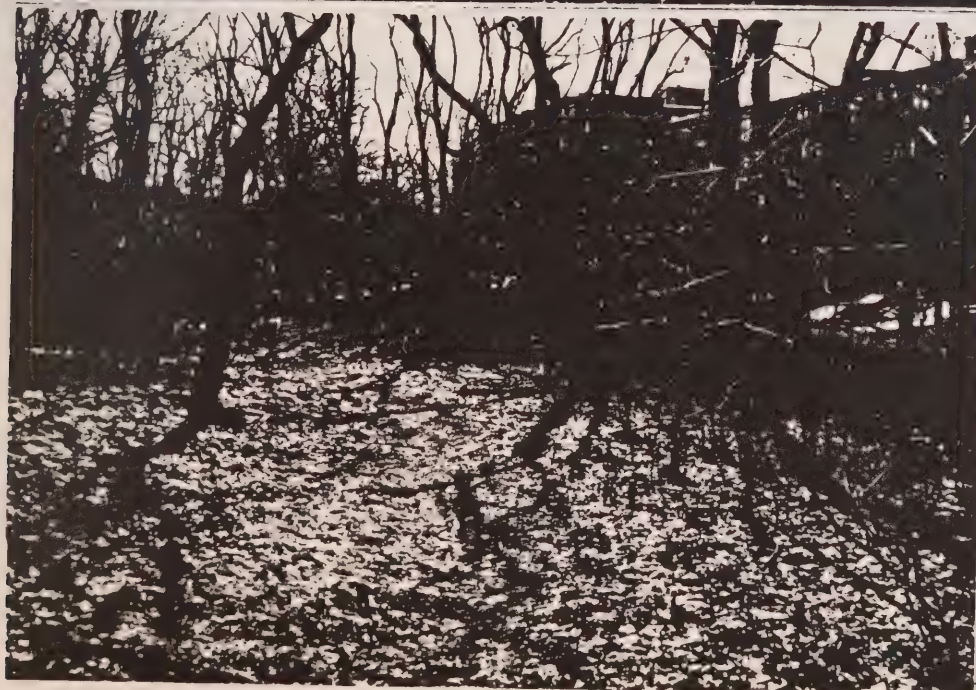
**Site Photograph 3**

Informal path through natural grove of locust trees. Has great potential if selectively pruned and planted.

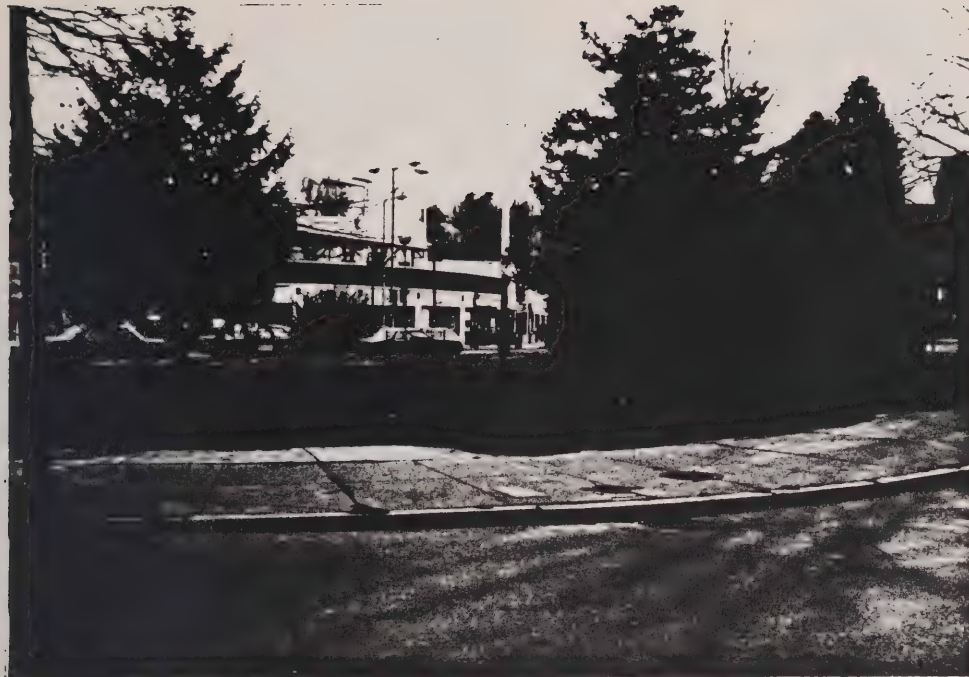
**Site Photograph 1**

View shows maturity of plant material, access point and one section of damaged fence. Flagpole in middle. Evergreen to left used as Christmas tree.

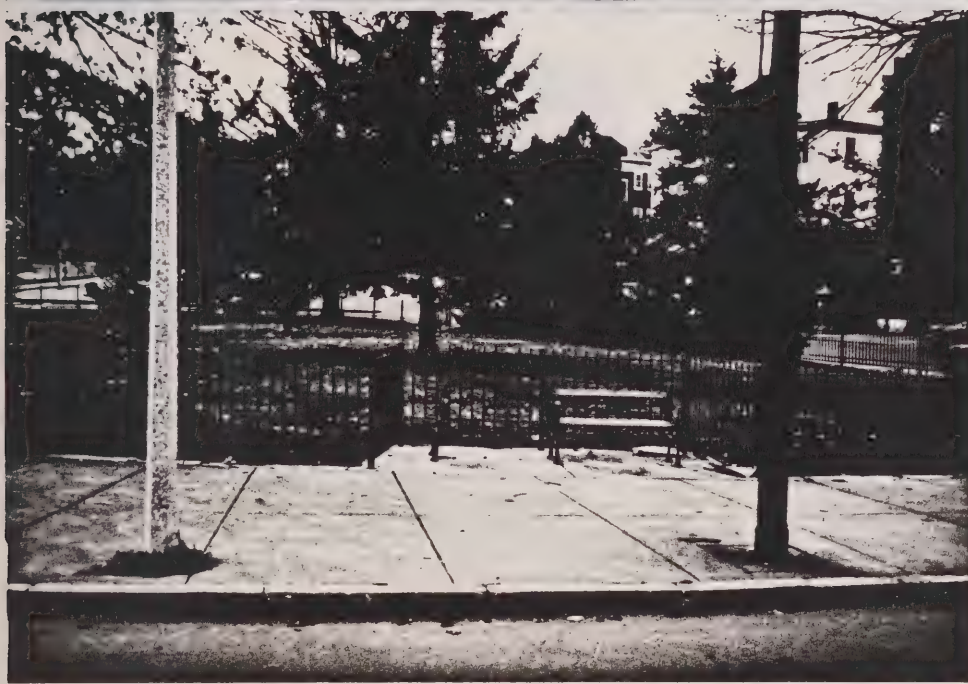
**Site Photograph 2**

Vandalized bench. Benches attractive but not durable.
